DCA00-MP009

MEMORANDUM

TO: Distribution
DATE: March 9, 1998
FROM: Principal Engineer and Principal Engineer
PLACE: Central Engineering
SUBJECT: Line 1103 Failure

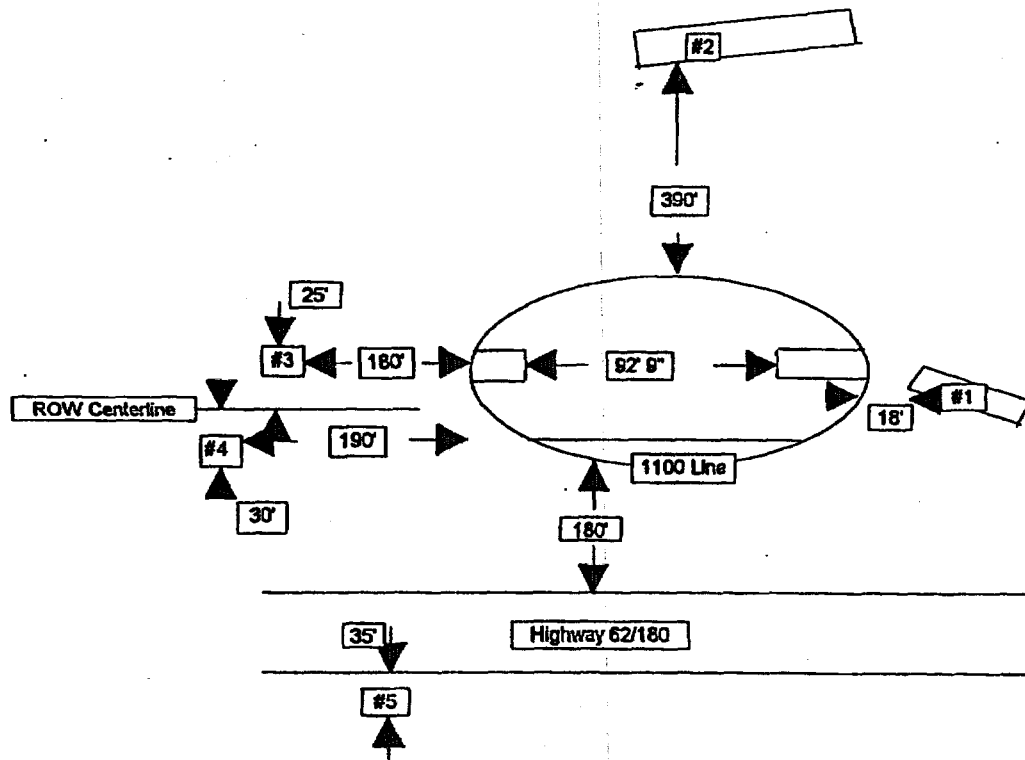
The 1103 Line rupture and subsequent gas flow exposed a portion of the adjacent 26 inch diameter 1100 Line, which was located an estimated 20 to 25 feet to the south, parallel to the 1103 Line centerline. The pipe was exposed from

about 5 to 2 o'clock looking east along the pipe as shown in Figures 1 and 2. The coating was burned off the majority of the exposed pipe and two wrinkle bends from original construction were visible toward the eastern end. Three random areas on the pipe were hardness tested to ensure that the rupture and subsequent fire had not affected the mechanical properties of the pipe. Hardness readings were taken in an area toward the center of the crater, on one of the exposed wrinkle bends and at an area which was thought to have been shielded from the gas escaping from the eastern end of the piping. All hardness readings were consistent with that of unaffected pipe. Hardness readings from the testing are included. The surface oxide coating was consistent with that of mill scale and not of pipe which had been subjected to direct flame impingement. The wrinkle bends were nondestructively examined for cracking using dry magnetic particles, with no cracking found. The line was returned to service based upon the findings of the evaluation.
