RAILROAD COMMISSION OF TEXAS  
PIPELINE SAFETY SECTION  
Study Report on  
***COMPRESSION TYPE COUPLINGS***

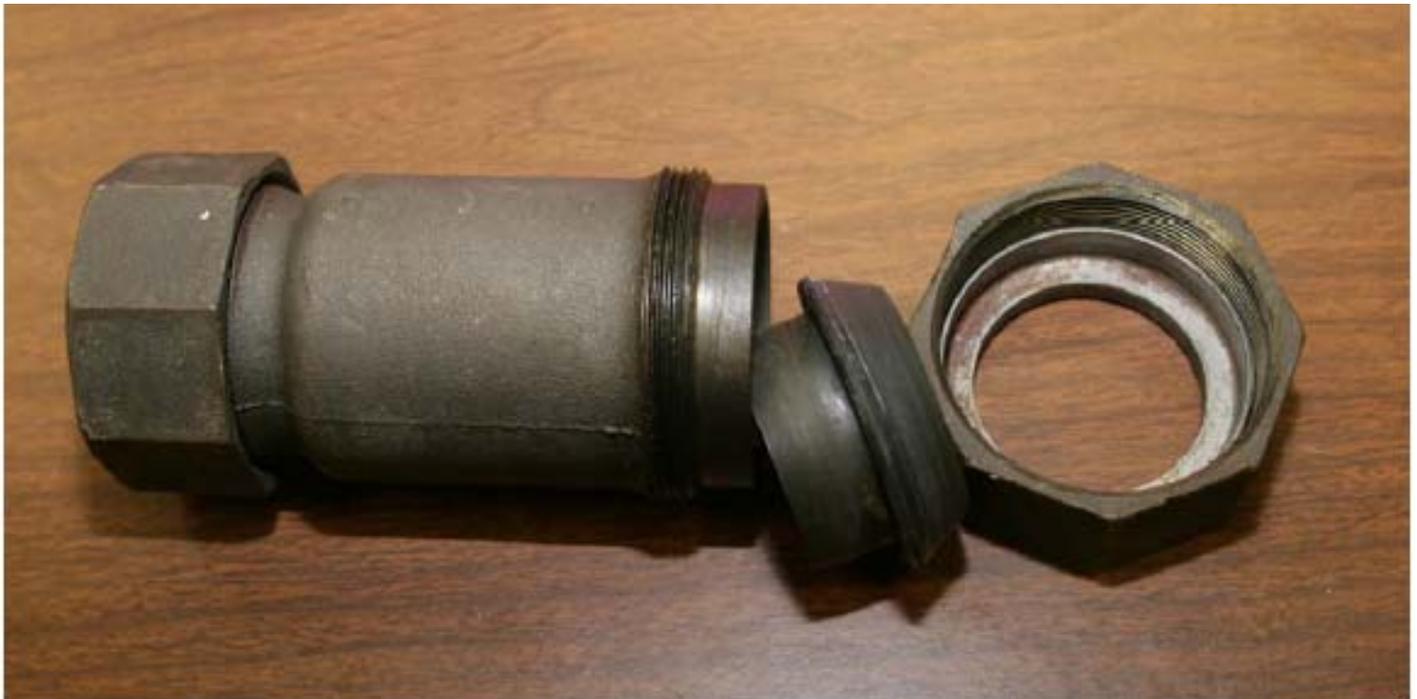
For the purpose of describing and explaining a typical coupling, the Dresser type coupling is pictured below. This information was extracted from a diagram created by PHMSA. Figures 1 and 2 provide examples of a typical Style 90 type Dresser coupling. A number of variations are available to join similar materials (such as steel to steel or PE to PE) or different materials (such as transitioning from steel to PE as in Figure 2). In addition to the straight coupling shown below, the Style 90 can also appear as an elbow (45 or 90 degree), tee, reducing coupling, or integrated with a riser. A variety of gaskets and sleeves exist depending on the specific application.

Figure 1 – Example of a Style 90 Type Dresser Coupling, Open Ended Barrel for View of Components

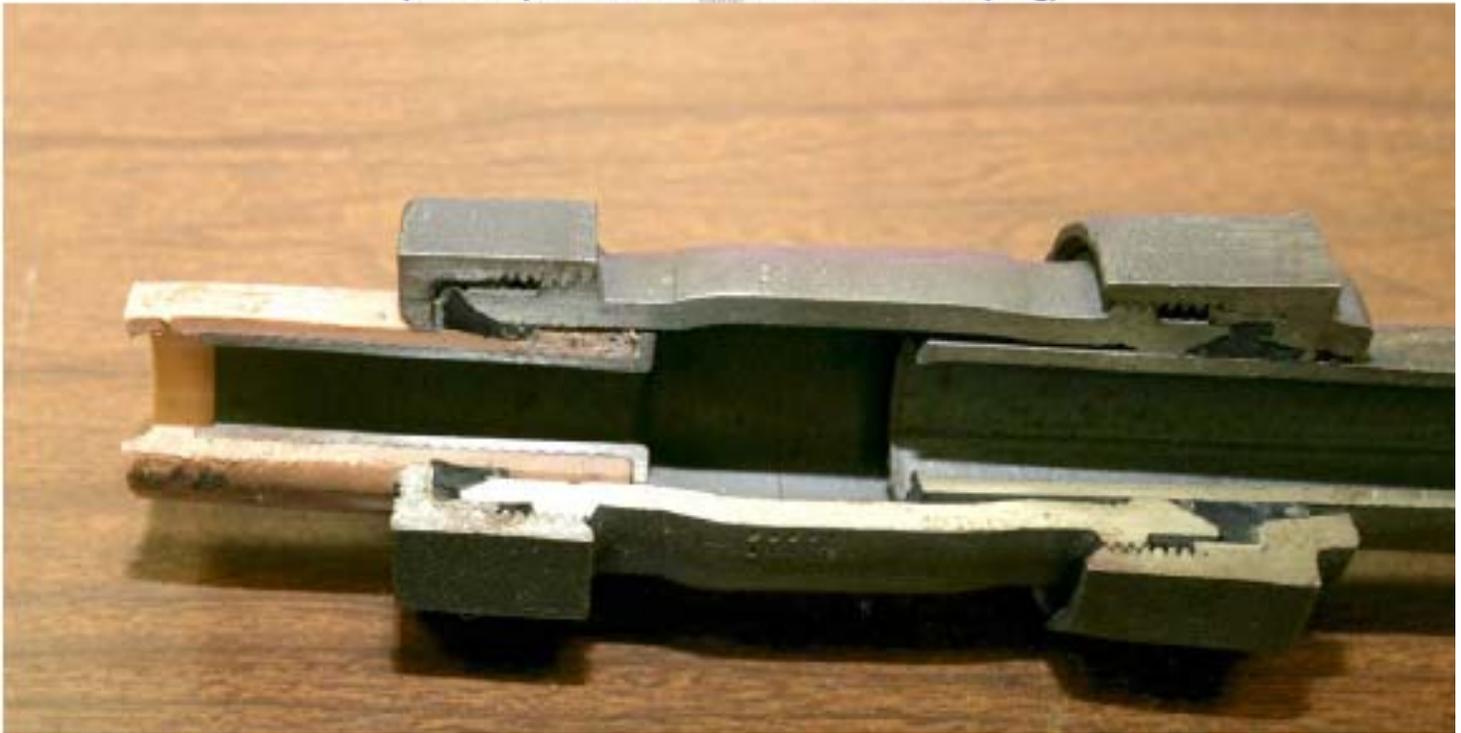
(Cut-away: Combination Plastic-to-Steel Coupling)

Figure 2 – Cut-away of Style 90 Type Dresser Coupling Transitioning Plastic to Steel

Figure 3 shows a schematic of the compression mechanism. From the Dresser Coupling website ([www.dressercoupling.com](http://www.dressercoupling.com)): “The “Universal” Style 90 locking design creates a positive pipe restraint. As the nut is tightened, it compresses the gasket, which forces the steel lock rings to collapse around the pipe end creating a strong grip. This gripping action actually increases as the pipe moves or attempts to pull out of the coupling. Properly assembled plastic pipe joints made with the Dresser “Universal” Style 90 product line meet or exceed the requirements of D.O.T 192.283(b).” In the cases of plastic pipe, an internal stiffener should be used, as shown in Figure 2.

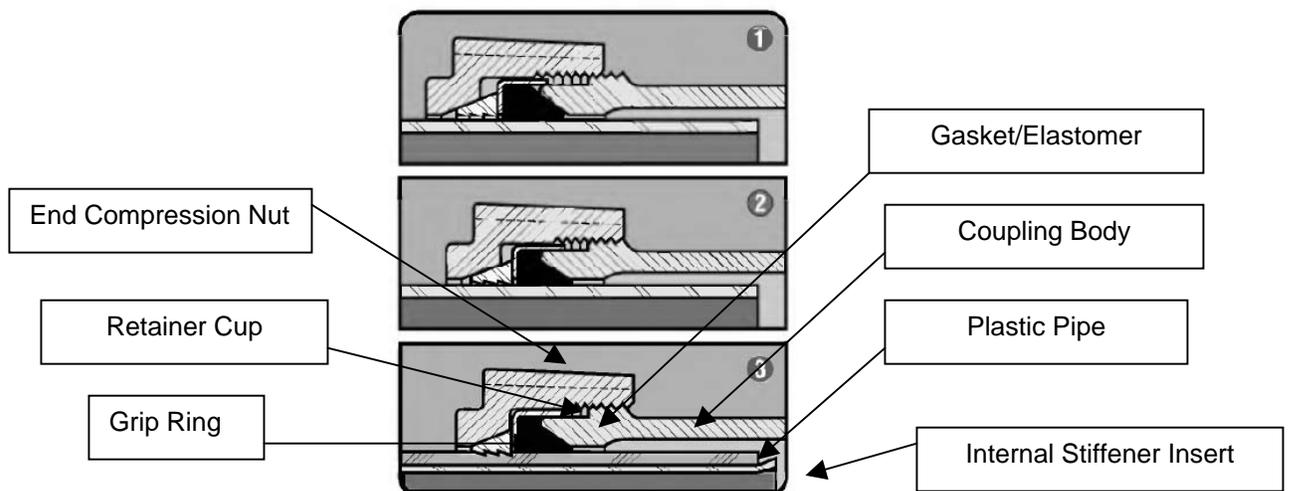
Figure 3 – Style 90 “Universal” end before tightening (1), after tightening onto steel pipe (2), and after tightening onto polyethylene pipe (3)
